**Flood Control Project Maintenance
Levee Inspections**

Fall 2018 Levee Maintenance Deficiency Summary Report

**Flood Control Project Maintenance
Levee Inspections****LMA District Cover Sheet****Fall 2018 Levee Inspection Results****Reclamation District No. 0563 Tyler Island**

Reclamation District No. 0563 Tyler Island

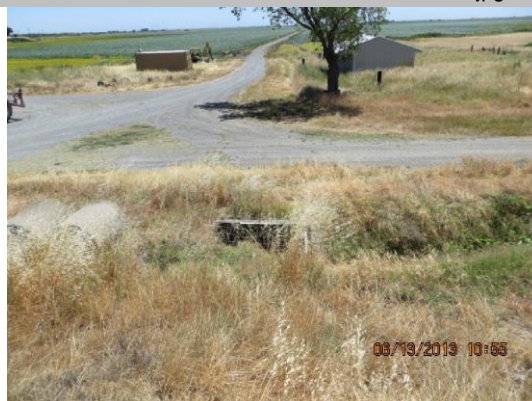
Photo 3 of 3 : UCIP_FA_2018_14990_24675.jpg

Comment Code						
Inspector Comment						
FS_ID:14990 DS_ID:20161 EP_NO: 11217 Repair Type: Non-Urgent Crossing Status: Found UCIP Comments: Pipe appears abandoned and should be done so properly. FIELD_STRUCT_DESC: 1 of 11: 12-inch steel irrigation siphon pipe through the levee, 3.6 feet below the crown. Vent/filler pipe on the landside (LS) shoulder, and a slide gate in a 7-foot by 9-foot concrete distribution box on the LS toe. (Automatic Board Order (ABO) issued as Permit No. 11217, 1975 - Owen E. Wilkenson). [Additional Reference(s): DWR Levee Log, 2005. USACE Sacramento O&M Manual 103, June 1954, (Station ""L "" 193+23.5)]. FS Date: 6/13/2013

7'X9' concrete distribution box on LS toe.

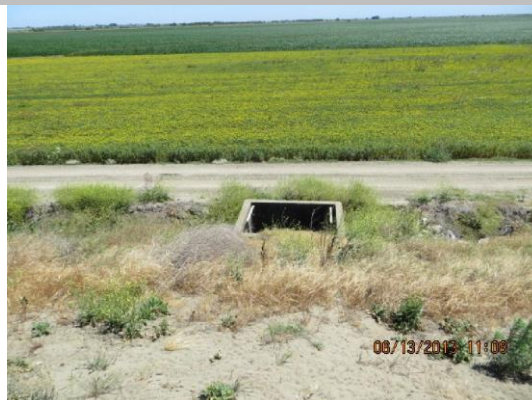
Photo 2 of 3 : UCIP_FA_2018_16292_27452.jpg

Concrete distribution box at LS toe.

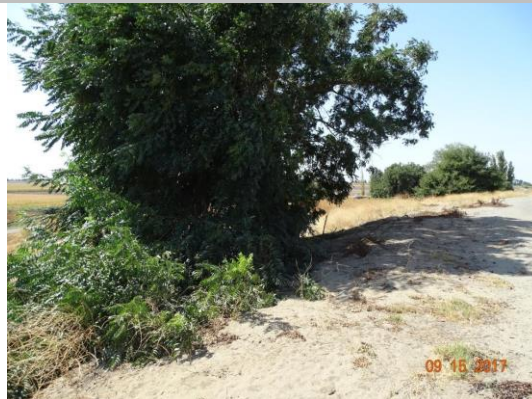
Photo 1 of 2 : FA_2018_RD0563_210_768_20180925_00118.jpg

LM Start	9.25	Rating **	M	Issue No.	768
LM End	9.25	Issue Type +	Ma	Location *	LS
Category	Earthen Levee			GPS Latitude/Longitude	
				Start	End
Item	Trim / Thin Trees			38.145897°	38.145897°
				-121.588203°	-121.588203°
DWR ID	DWR_RD0563_01_s_2015_768				
Comment Code					
T1 : Trim trees to at least five feet above ground level.					
Inspector Comment

Looking south at the landside slope.

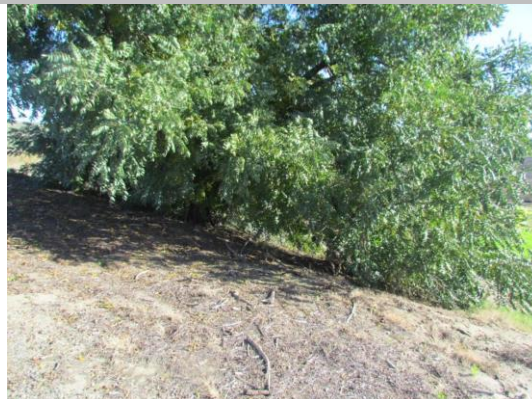
Photo 2 of 2 : FA_2018_RD0563_210_768_20180925_00119.jpg

Looking at untrimmed tree on landward slope.

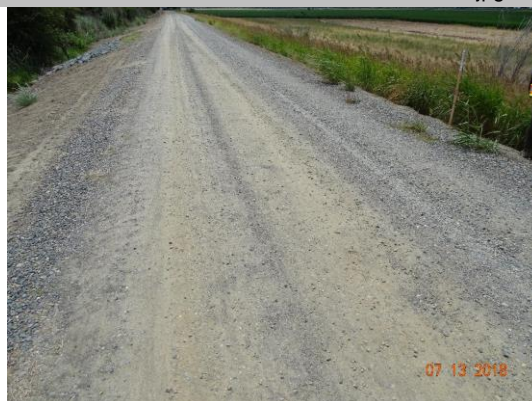
Photo 1 of 2 : UCIP_FA_2018_52765_77766.jpg

Comment Code					
Inspector Comment					
FS_ID:52765 DS_ID:20166 EP_NO: 11217 Repair Type: Non-Urgent Crossing Status: Found UCIP Comments: 06/13/2018 Appears abandoned as stand pipe is partially filled with soil. Abandon properly. No pictures taken. (W.Wylie) FIELD_STRUCT_DESC: 10-inch steel irrigation pipe through the levee, 3.8 feet below the crown. Vent/filler pipe on the landside (LS) shoulder. 4-foot-diameter concrete standpipe on the LS toe. (Automatic Board Order (ABO) issued as Permit No. 11217, 1975 - Owen E. Wilkenson). [Additional Reference(s): DWR Levee Log, 2005. USACE Sacramento O&M Manual 103, June 1954, (Station ""L"" 136+45.1)]. FS Date: 7/13/2018

View of levee crown at the crossing.

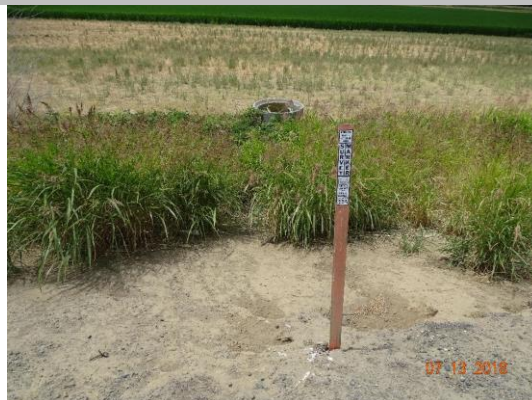
Photo 2 of 2 : UCIP_FA_2018_52765_77767.jpg

View of standpipe on IS.

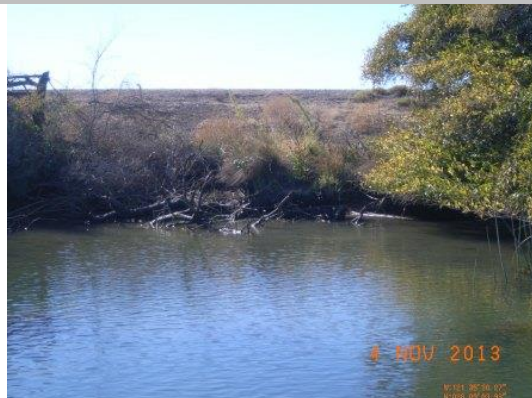
Photo 1 of 1 : FA_2018_RD0563_210_82_20181023_00228.jpg

LM Start	9.73	Rating **	A/W	Issue No.	82
LM End	9.90	Issue Type +	Ma	Location *	WS
Category	Supplemental			GPS Latitude/Longitude	
				Start	End
Item	2017 USACE Erosion Survey, DRAFT			38.150820 °	38.150647 °
				-121.593650 °	-121.596858 °
DWR ID	DWR_RD0563_01_f _ 2018_82				
Comment Code					
Inspector Comment					
2017 Site ID: GEO 2.5 L					
Status: Eroding					
2017 Field Notes: Head scarp observed.					
Site History: 1997 - Erosion pockets into the toe of the levee. 2001 - Staked low fascine walls at the bankline. 2004 - Numerous "Brush Boxes." 2005 - Some new bundles in the brush boxes. 2012 - Site extended downstream to account for new bank sloughing. 2013 - Some rock added to the upstream end by the local RD.

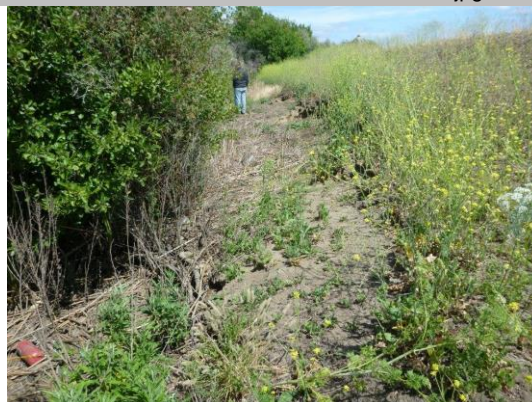
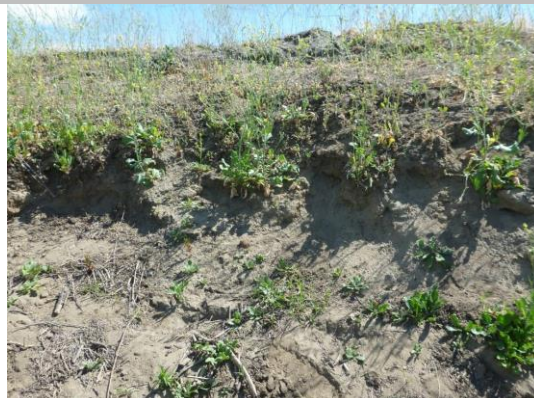
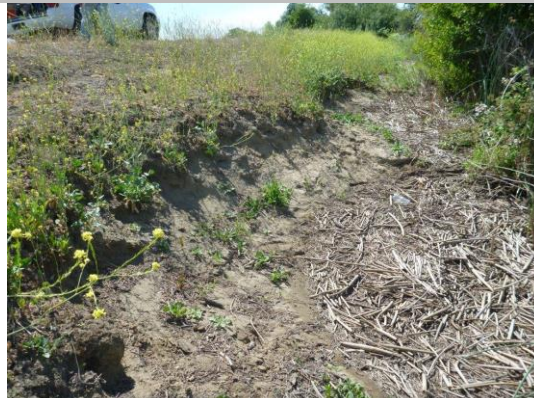
LM Start	9.73	Rating **	A/W	Issue No.	105	
LM End	9.78	Issue Type +	Ma	Location *		
Category	Supplemental			GPS Latitude/Longitude		
				Start		End
Item	2017 Storm Damage			38.150820 °		38.151196 °
				-121.593650 °		-121.594780 °
DWR ID	DWR_RD0563_01_s_2018_105					
Comment Code						
Inspector Comment						
Levee Evaluation Comments						
Description:						
Site ID No:70						
Site Designation:DWR_RD0563_01_s_2012_49						
Repair Type: Erosion						
Rating:Serious						
Field Date:6/9/2017						
Notes:

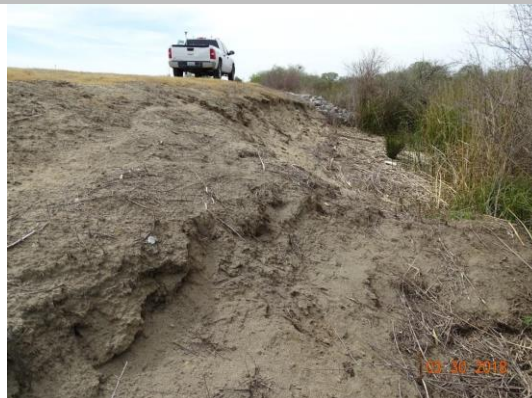
Photo 1 of 1 : FA_2018_RD0563_210_124_20180925_00085.jpg

LM Start	9.87	Rating **	U	Issue No.	124
LM End	9.87	Issue Type +	Ma	Location *	WS
Category	Earthen Levee			GPS Latitude/Longitude	
				Start	End
Item	Erosion / Bank Caving			38.150800 °	38.150800 °
				-121.596297 °	-121.596297 °
DWR ID	DWR_RD0563_01_s_2018_124				
Comment Code					
E2 : Schedule repair of erosion site prior to the next inspection.					
Inspector Comment					
Severe erosion site on sandy levee should be monitored and repaired before winter 2018/19.

Erosion in sandy levee should be repaired and site protected from future erosion.

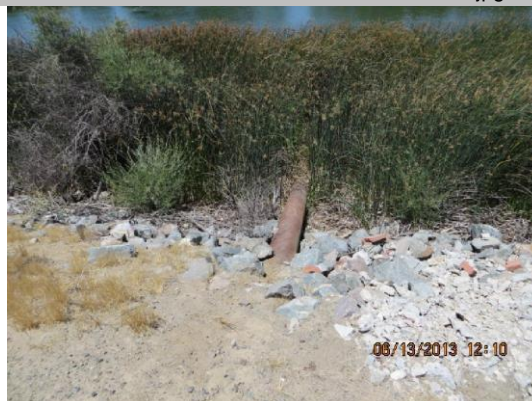
Photo 1 of 3 : UCIP_FA_2018_52766_24688.jpg

Comment Code					
Inspector Comment					
FS_ID:52766 DS_ID:20167 EP_NO: 11217 Repair Type: Non-Urgent Crossing Status: Found UCIP Comments: 07/13/2018 Fall hazard: 5-foot-diameter steel standpipe on LS needs to be covered. (O.Yakimov-DWR UCIP) FIELD_STRUCT_DESC: 14-inch steel irrigation siphon pipe through the levee, 4.3 feet below the crown. Vent/filler pipe on the landside (LS) shoulder, and a slide gate in a 5-foot-diameter steel standpipe at the LS toe. (Automatic Board Order (ABO) issued as Permit No. 11217, 1975 - Owen E. Wilkenson). [Additional Reference(s): DWR Levee Log, 2005. USACE Sacramento O&M Manual 103, June 1954, (Station ""L"" 119+16) (16-inch pipe listed)]. FS Date: 7/13/2018

Pipe visible on WS slope.

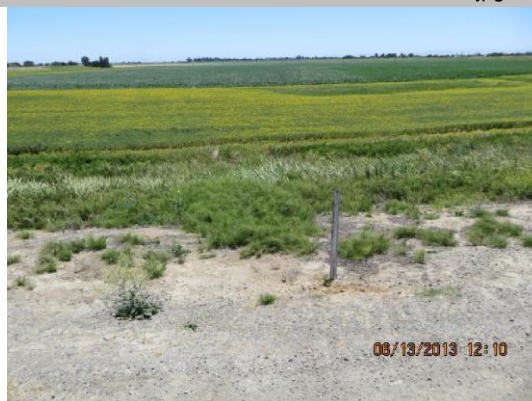
Photo 2 of 3 : UCIP_FA_2018_52766_24687.jpg

vent and standpipe visible on LS slope.

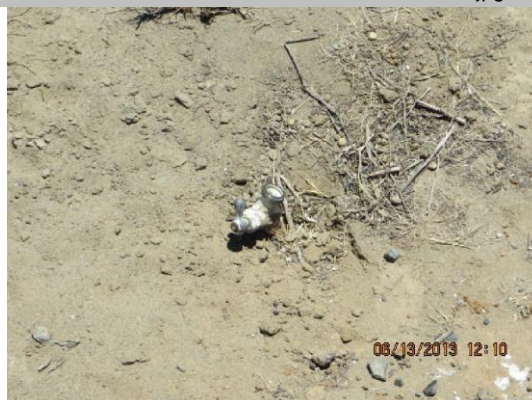
Photo 3 of 3 : UCIP_FA_2018_52766_24686.jpg

Vent/filler pipe on LS shoulder.

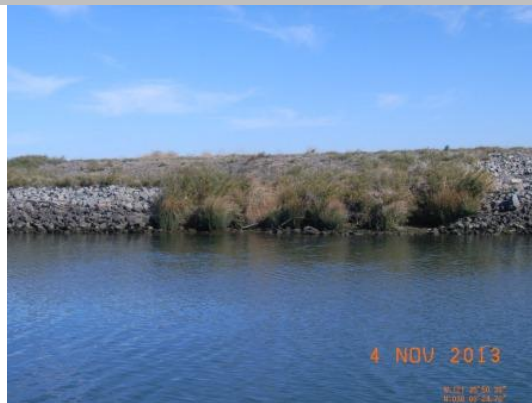
Photo 1 of 1 : FA_2018_RD0563_210_65_20181023_00111.jpg

LM Start	10.45	Rating **	M	Issue No.	65
LM End	10.74	Issue Type +	Ma	Location *	WS
Category	Supplemental			GPS Latitude/Longitude	
				Start	End
Item	2017 USACE Erosion Survey, DRAFT			38.143519 °	38.139918 °
				-121.599677 °	-121.596986 °
DWR ID	DWR_RD0563_01_f_2018_65				
Comment Code					
Inspector Comment					
2017 Site ID: GEO 1.7 L Status: Eroding 2017 Field Notes: New rock placed in erosion pockets , site has improved wih work done by RD, but still some erosion pockets and toe erosion. Slump failure with headscarp at downstream end. Site History: 1997 - Old damaged rock riprap along the toe. 1999 - Downstream end (400 ft) repaired with rock. 2002 - New rock/concrete rubble section on the downstream end. 2004 - Small pocket repairs at the downstream end. 2005 - Some new bundles in the brush boxes. 2012 - Some rock has been placed in last year.

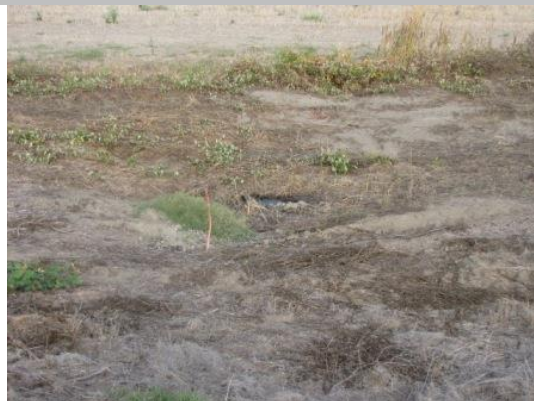
Photo 2 of 4 : FA_2018_RD0563_210_76_20180925_00040.jpg

LM Start	10.59	Rating **	M	Issue No.	76
LM End	10.59	Issue Type +	Ma	Location *	LS
Category	Earthen Levee			GPS Latitude/Longitude	
				Start	End
Item	Slope Stability			38.141940 °	38.141940 °
				-121.598033 °	-121.598033 °
DWR ID	DWR_RD0563_01_s_2012_76				
Comment Code					
S1 : Repair slope instability.					
Inspector Comment					
Deep depression on landside shoulder and slope; possible pipe collapse.

Looking east at water ponding at landside toe just above 10" irrigation pipe.

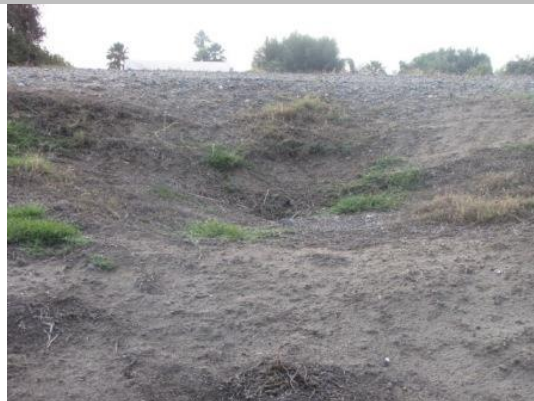
Photo 3 of 4 : FA_2018_RD0563_210_76_20180925_00041.jpg

Looking west at depression on landside shoulder and slope from landside toe.

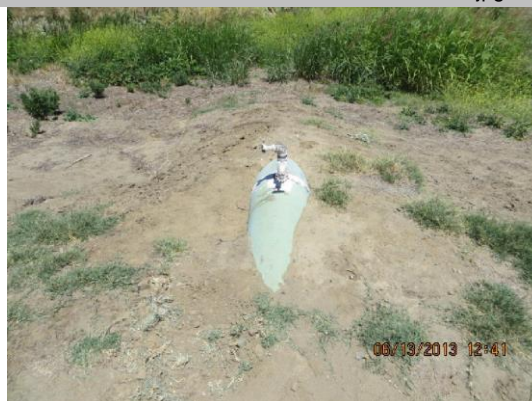
Photo 1 of 3 : UCIP_FA_2018_52767_24691.jpg

Comment Code						
Inspector Comment						
FS_ID:52767 DS_ID:20170 EP_NO: 11217 Repair Type: Non-Urgent Crossing Status: Found UCIP Comments: 06/13/2013 Pipe does not have appropriate clearance at Levee crown. (W.Wylie) FIELD_STRUCT_DESC: 16-inch steel irrigation siphon pipe through the levee, 1 foot below the crown. Air vent/filler pipe on the landside (LS) shoulder. Slide gate in a 5-foot-diameter steel standpipe on the LS toe. (Automatic Board Order (ABO) issued as Permit No. 11217, 1975 - Owen E. Wilkenson). [Additional Reference(s): DWR Levee Log, 2005. USACE Sacramento O&M Manual 103, June 1954, (Station ""L"" 60+34) (14-inch pipe listed)]. FS Date: 7/13/2018

Vent/filler on pipe at LS shoulder.

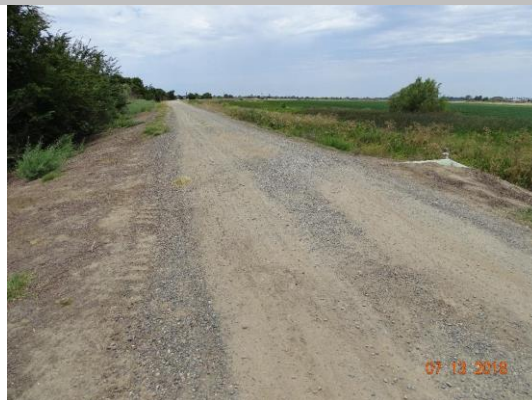
Photo 2 of 3 : UCIP_FA_2018_52767_77770.jpg

View of levee crown at the crossing.

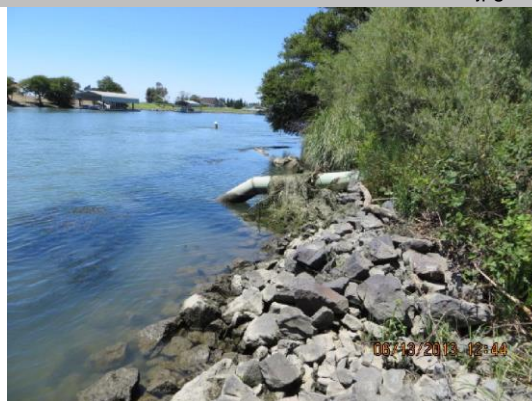
Photo 3 of 3 : UCIP_FA_2018_52767_24689.jpg

Pipe visible on WS toe.

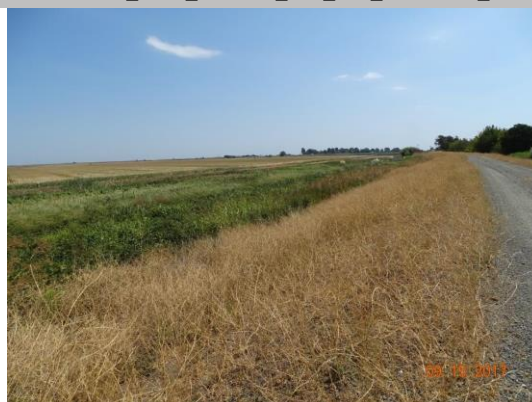
Photo 1 of 3 : FA_2018_RD0563_210_770_20180925_00121.jpg

LM Start	11.01	Rating **	M	Issue No.	770
LM End	12.00	Issue Type +	Ma	Location *	LS
Category	Earthen Levee			GPS Latitude/Longitude	
				Start	End
Item	Vegetation			38.136623 °	38.130739 °
				-121.594216 °	-121.579678 °
DWR ID	DWR_RD0563_01_s_2015_770				
Comment Code					
V2 : Remove the wild growth other than native grasses from the levee slopes.					
Inspector Comment					
Dense veg (wildroses) at landside toe.

Looking southeast at the landside slope.

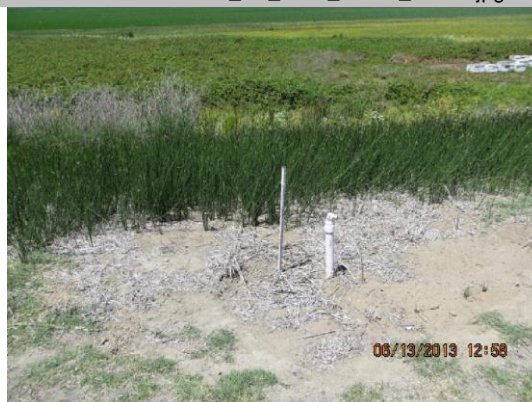
Photo 1 of 3 : UCIP_FA_2018_52769_24705.jpg

FS_ID:52769
DS_ID:20174
EP_NO: 11217
Repair Type: Non-Urgent
Crossing Status: Found
UCIP Comments: 06/13/2013 Pipe appears abandoned and should be done so properly. (W.Wylie)
FIELD_STRUCT_DESC: 12-inch steel irrigation siphon pipe through the levee, 4.5 feet below the crown. Air vent on the landside (LS) shoulder, and slide gate in a 7-foot by 9-foot concrete distribution box at the LS toe. (Automatic Board Order (ABO) issued as Permit No. 11217, 1975 - Owen E. Wilkenson). [Additional Reference(s): DWR Levee Log, 1980. USACE Sacramento O&M Manual 103, June 1954, (Station "'L"' 19+23.5)].
FS Date: 7/13/2018

Vent and distribution box visible on LS.

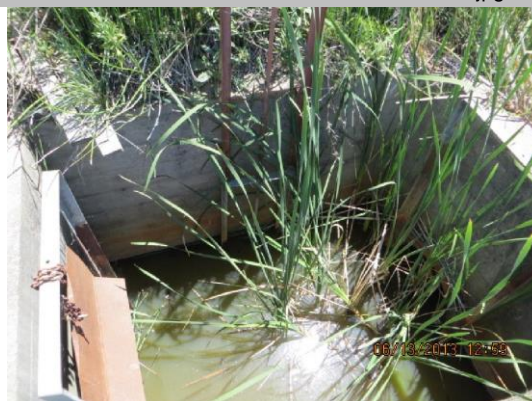
Photo 2 of 3 : UCIP_FA_2018_52769_24704.jpg

Distribution box and slide gate visible on LS toe.

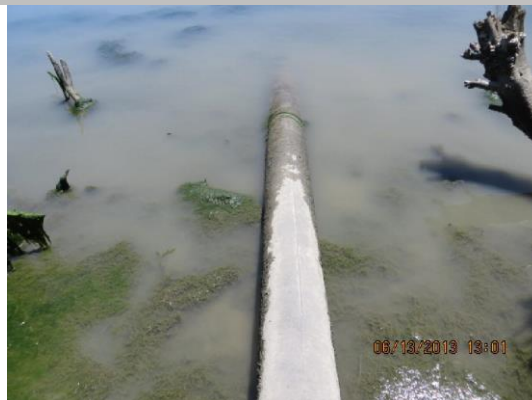
Photo 3 of 3 : UCIP_FA_2018_52769_24703.jpg

Pipe visible on WS toe.

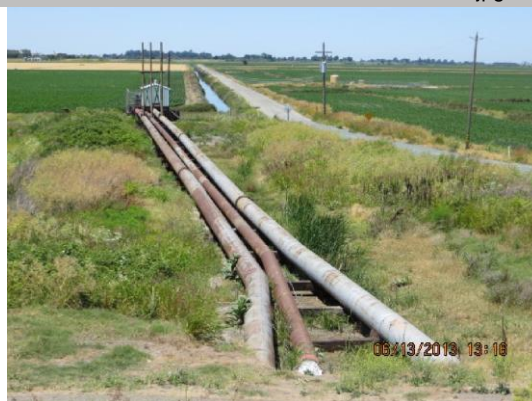
Photo 1 of 3 : UCIP_FA_2018_52771_24731.jpg

Pump and pipes off LS toe.

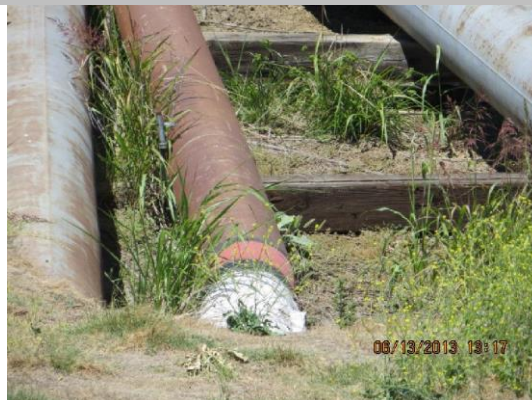
Photo 2 of 3 : UCIP_FA_2018_52771_24730.jpg

20-inch pipe on LS toe.

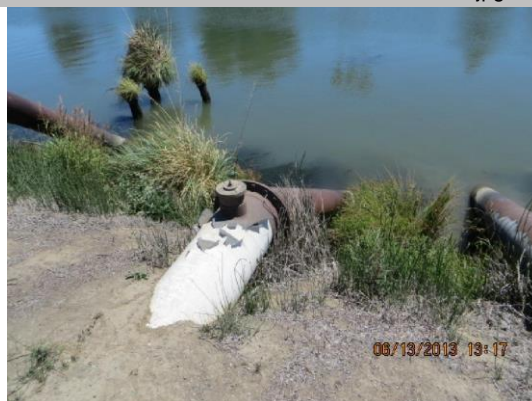
Photo 3 of 3 : UCIP_FA_2018_52771_24729.jpg

Pipe and siphon breaker on WS shoulder.

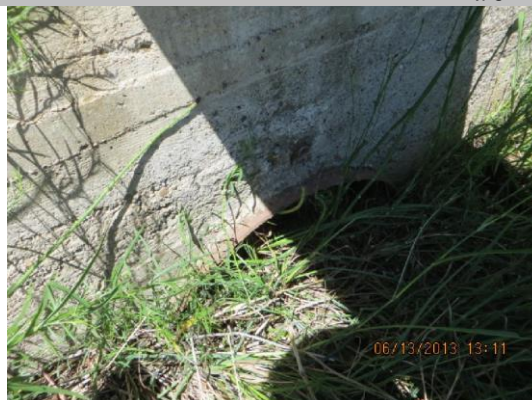
Photo 1 of 2 : UCIP_FA_2018_15028_24736.jpg

LM Start	12.00	Rating **	M	Issue No.	807
LM End	12.00	Issue Type +	En	Location *	
Category	Supplemental			GPS Latitude/Longitude	
				Start	End
Item	DWR UCIP Field Study			38.130730 °	38.130730 °
				-121.579616 °	-121.579616 °
DWR ID	20182				
Comment Code					
Inspector Comment					
FS_ID:15028					
DS_ID:20182					
EP_NO: N/A					
Repair Type: Non-Urgent					
Crossing Status: Found					
UCIP Comments: Verify pipe is properly abandoned.					
FIELD_STRUCT_DESC: *REMOVED* 1 of 2: 36-inch steel drainage pipe through the levee, 4 feet below the crown. Shutoff valve at pump. Pipe visible on the waterside (WS) at headwall. (Replaced by a 30-inch pipe under Permit No. 2635, 1957 - Reclamation District No. 563). [Additional Reference(s): USACE Sacramento O&M Manual 103, June 1954, (Station ""L"" 6+39)].					
FS Date: 6/13/2013

Pipe at concrete headwall on WS slope.

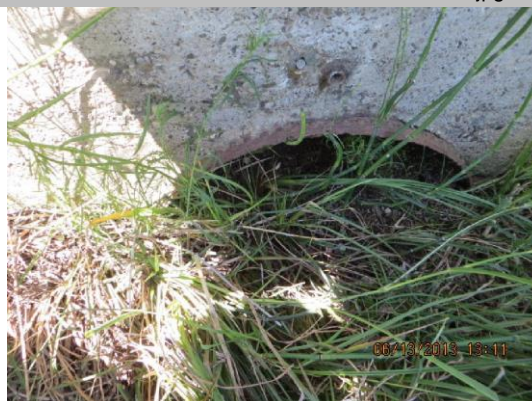
Photo 2 of 2 : UCIP_FA_2018_15028_24735.jpg

LM Start	12.00	Rating **	M	Issue No.	807 (cont)
LM End	12.00	Issue Type +	En	Location *	
Category	Supplemental			GPS Latitude/Longitude	
				Start	End
Item	DWR UCIP Field Study			38.130730 °	38.130730 °
				-121.579616 °	-121.579616 °
DWR ID	20182				
Comment Code					
Inspector Comment					
FS_ID:15028 DS_ID:20182 EP_NO: N/A Repair Type: Non-Urgent Crossing Status: Found UCIP Comments: Verify pipe is properly abandoned. FIELD_STRUCT_DESC: *REMOVED* 1 of 2: 36-inch steel drainage pipe through the levee, 4 feet below the crown. Shutoff valve at pump. Pipe visible on the waterside (WS) at headwall. (Replaced by a 30-inch pipe under Permit No. 2635, 1957 - Reclamation District No. 563). [Additional Reference(s): USACE Sacramento O&M Manual 103, June 1954, (Station ""L"" 6+39)]. FS Date: 6/13/2013

Pipe at concrete headwall on WS slope.

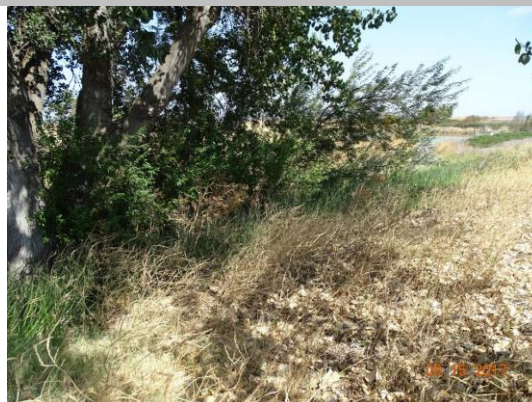
Photo 1 of 2 : FA_2018_RD0563_210_47_20180925_00019.jpg

LM Start	12.04	Rating **	M	Issue No.	47
LM End	12.04	Issue Type +	Ma	Location *	LS
Category	Earthen Levee			GPS Latitude/Longitude	
				Start	End
Item	Trim / Thin Trees			38.130758 °	38.130758 °
				-121.579027 °	-121.579027 °
DWR ID	DWR_RD0563_01_s_2012_47				
Comment Code					
T1 : Trim trees to at least five feet above ground level.					
Inspector Comment					
Trim tree on landside slope.

Looking northeast at the landside slope.

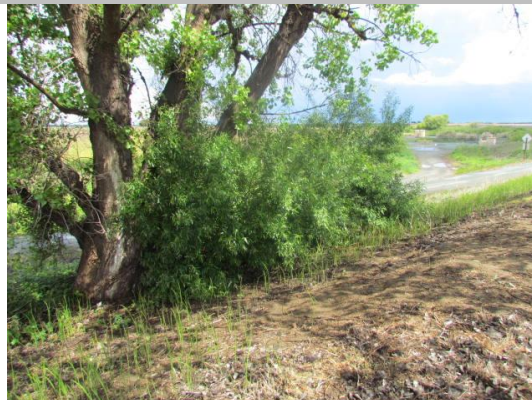
Photo 2 of 2 : FA_2018_RD0563_210_47_20180925_00020.jpg

LM Start	12.04	Rating **	M	Issue No.	47 (cont)	
LM End	12.04	Issue Type +	Ma	Location *	LS	
Category	Earthen Levee			GPS Latitude/Longitude		
				Start	End	
Item	Trim / Thin Trees			38.130758 °	38.130758 °	
				-121.579027 °	-121.579027 °	
DWR ID	DWR_RD0563_01_s_2012_47					
Comment Code						
T1 : Trim trees to at least five feet above ground level.						
Inspector Comment						
Trim tree on landside slope.

Looking northeast at untrimmed tree at landward slope. (Spring 2015)
